THE NORTHRIDGE BLUFF LANDSLIDE: RAPID BLUFF RETREAT ASSOCIATED WITH A MAJOR COASTAL LANDSLIDE IN DALY CITY, CALIFORNIA

Philip L. Johnson¹ & Dale R. Marcum¹

¹*Cotton, Shires & Associates, Inc. 330 Village Lane, Los Gatos, CA 95030*

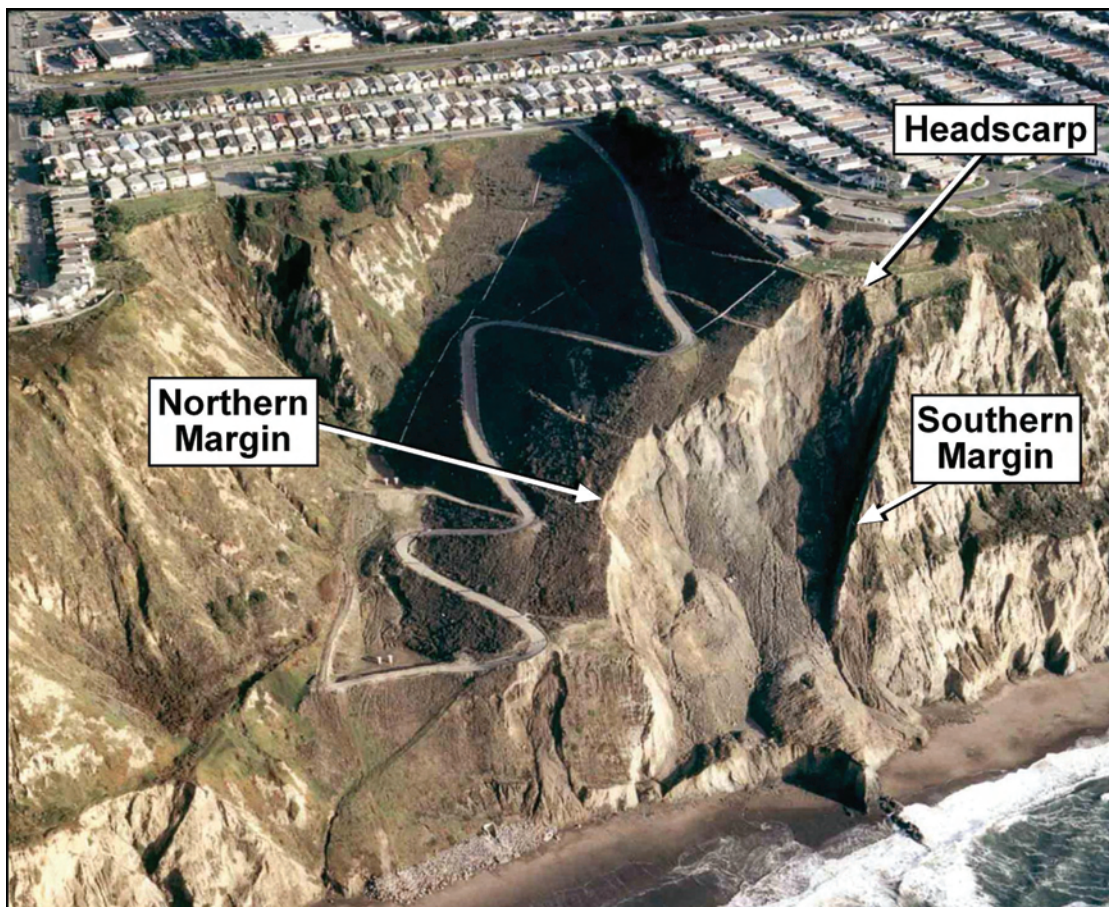
Figure 1. Oblique aerial photograph of the Northridge Bluff Landslide taken within two weeks after the December 2003 failure.

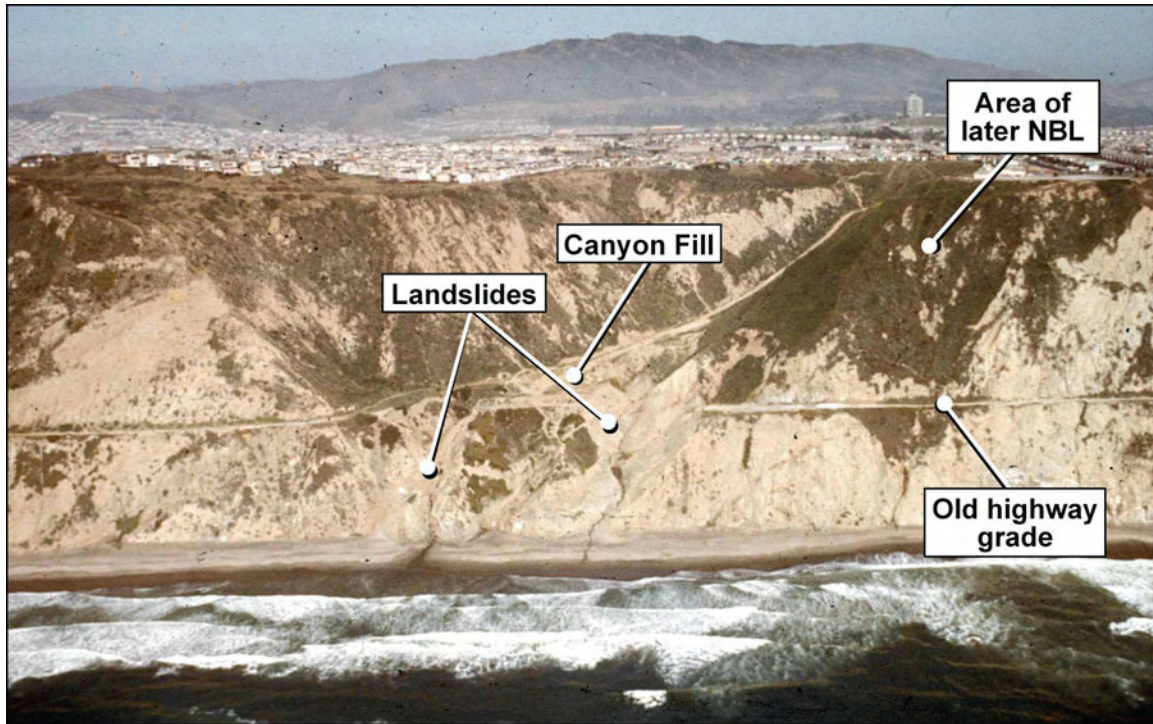
The earliest aerial photographs of Northridge Bluff show no evidence of a deep-seated landslide mass at the current location of the NBL. However, numerous shallow historical failures have locally stripped away surficial deposits and vegetation to expose the underlying bedrock within the bluff. Northward-dipping stratification is visible in oblique aerial photographs of the bluff (Figure 3).

Figure 3. Oblique aerial photograph of Northridge Bluff taken during October 1972. Published by permission of Kenneth and Gabrielle Adelman, California Coastal Records Project.

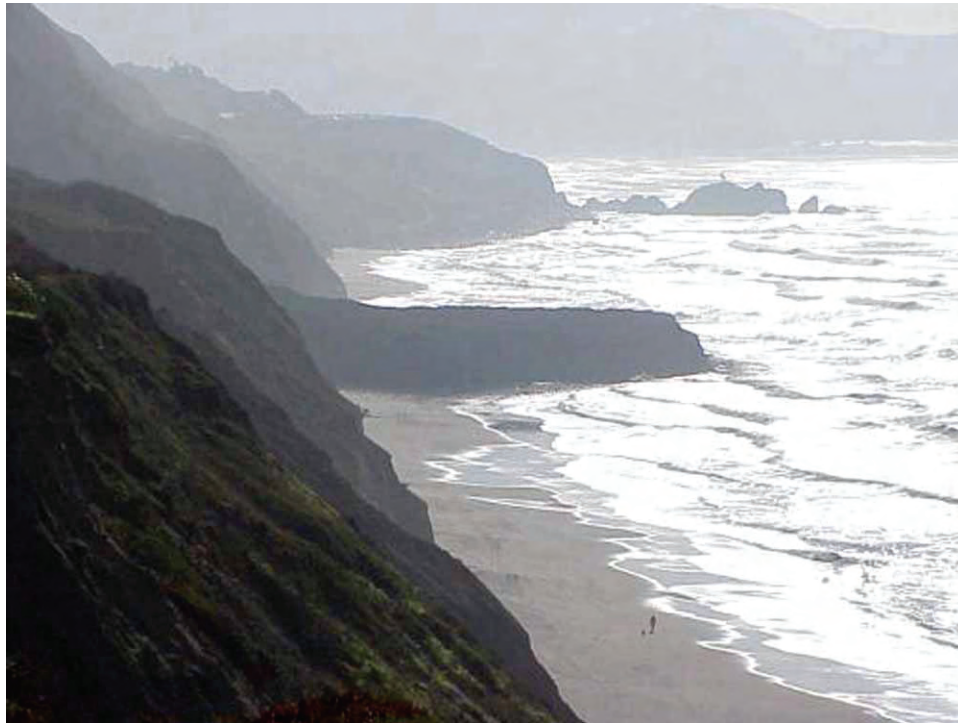
The Northridge Bluff Landslide failed dramatically sometime during the morning of December 20, 2003. Local residents noted that the landslide had extended out in to the surf zone more than 100 meters from the base of the sea cliff (Figure 4). A review of aerial photographs indicates that an initial stage of failure of the NBL began by the spring of 1998, and by August of 2000 the boundaries of the landslide were fully formed.

Figure 4. Photograph of the toe of the Northridge Bluff Landslide during December 21, 2003, within approximately 36 hours of the failure. Muscle rock is the prominent headland in the background, and the toe of the NBL (small peninsula) is in the center of the photograph. A person walking on the beach in foreground provides an approximate scale. Photograph by Jeff Poskanzer.

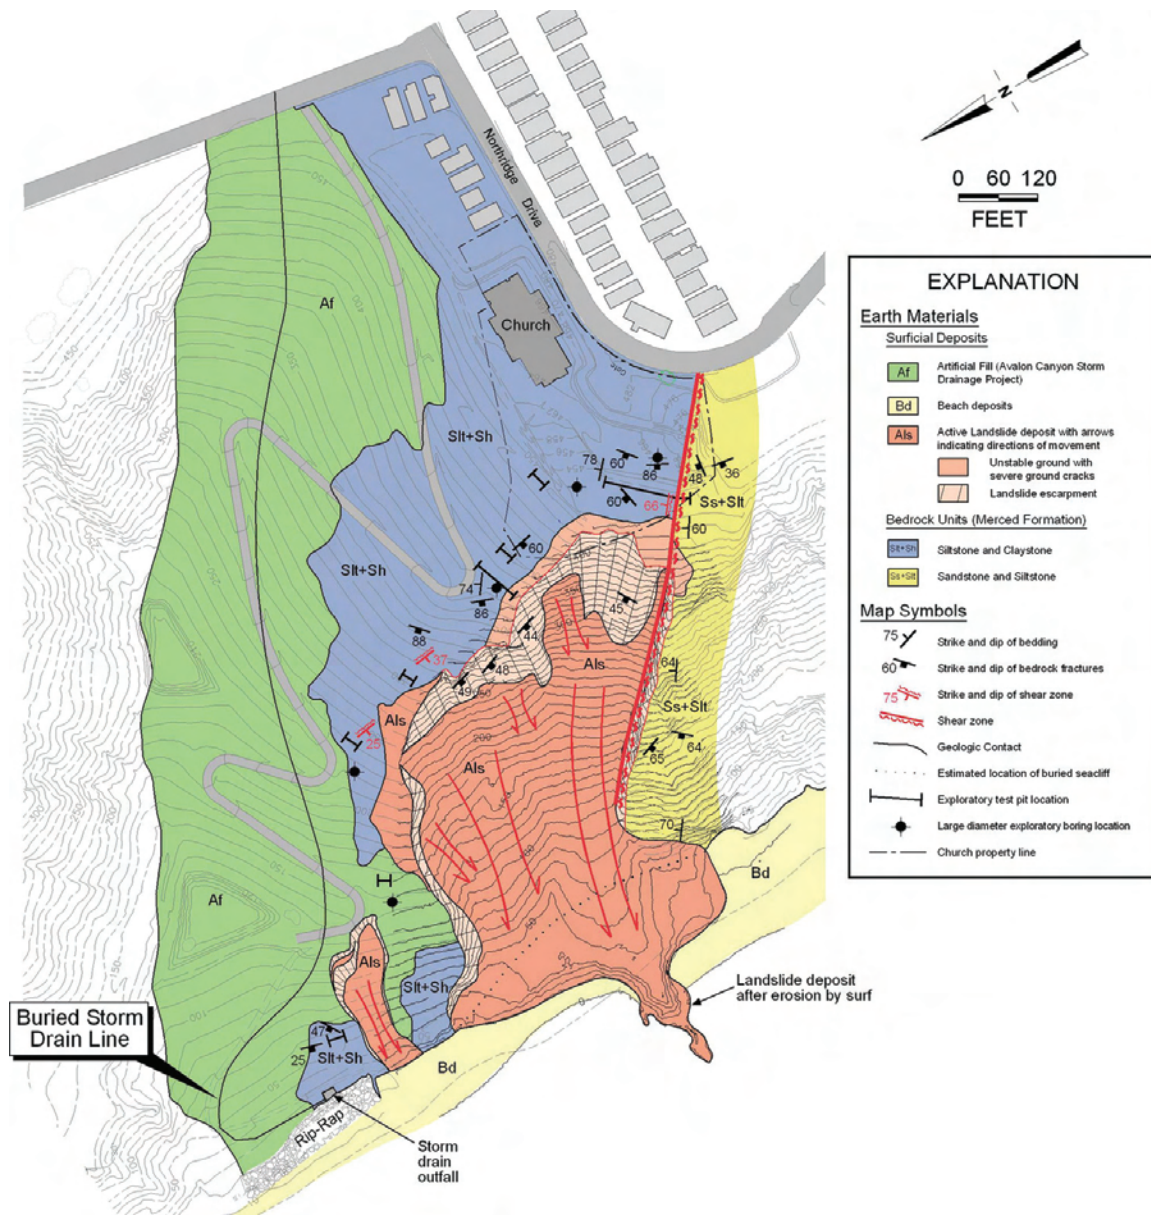
Figure 5. Engineering geologic map of the Northridge Bluff Landslide.

A sharp ridge that follows bedding within the Merced Formation defines the southern margin of the NBL. Bedding within this area of the bluff is oriented N60W and dips of 50-70 degrees to the north. The contact between resistant sandstone and the overlying highly sheared and weak claystone forms this apparent “strike-ridge”. This sheared claystone is laterally continuous and can be followed eastward from the bluff and outside the landslide area. Within this sheared claystone bed, there is a 1-meter thick highly plastic clay gouge. Given the lateral extent and the degree of gouge development, it appears that shearing must predate the recent landsliding. This prior deformation may be related to flexural slip during regional tectonic folding of the Pliocene bedrock (Bonilla, 1971). The presence of this highly sheared claystone bed within the Merced Formation provided a weak surface for failure of the landslide.

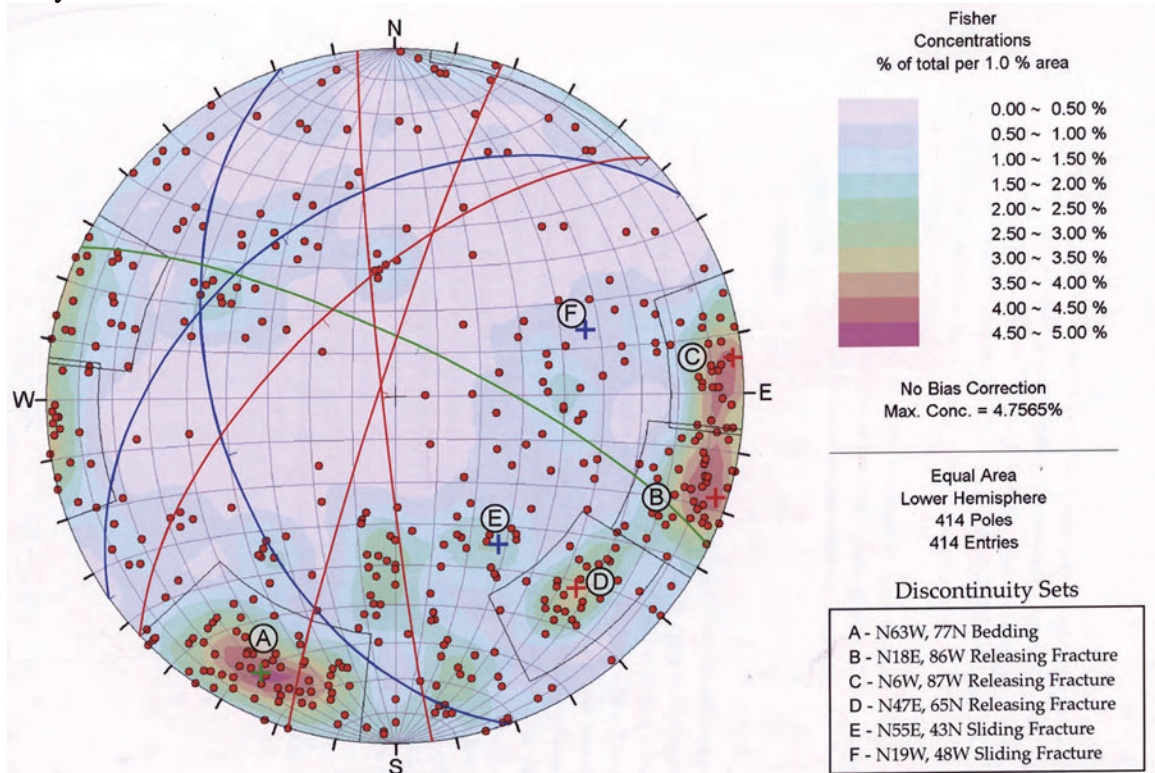
Clearly though, the failure of these high bluffs could not be controlled entirely by sliding along weak bedding planes. We mapped several sets of well-defined bedrock fractures within the bluff surrounding the NBL, and based upon our analysis of 414 measurements of fracture and bedding orientations, it appears that fractures played a significant role in the failure of the NBL. The orientations of distinct fracture sets are shown in a stereonet plot (Figure 6). These fracture sets can be grouped as either sliding fractures that dip shallowly seaward and allow sliding of blocks or releasing fractures that dip steeply and open in tension to allow release of blocks that slide downslope. These sliding fractures and releasing fractures, along with weak bedding planes combined to form a series of wedge failures (Figure 7). Large releasing and sliding fracture surfaces are exposed in the portion of the escarpment that forms the headscarp and the northern perimeter of the NBL (Figure 7). Along the southern margin, the failure followed the sheared claystone bed.

Figure 6. Stereonet plot of orientations of fractures and bedding measured in the area surrounding the landslide.

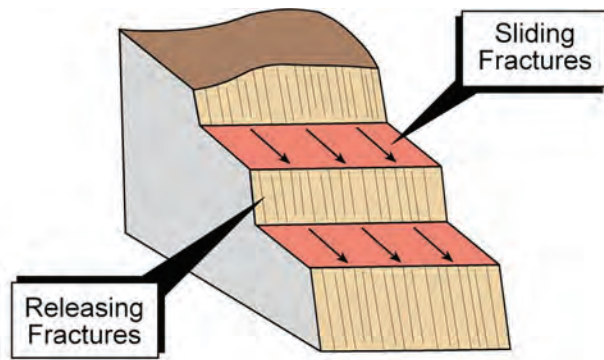
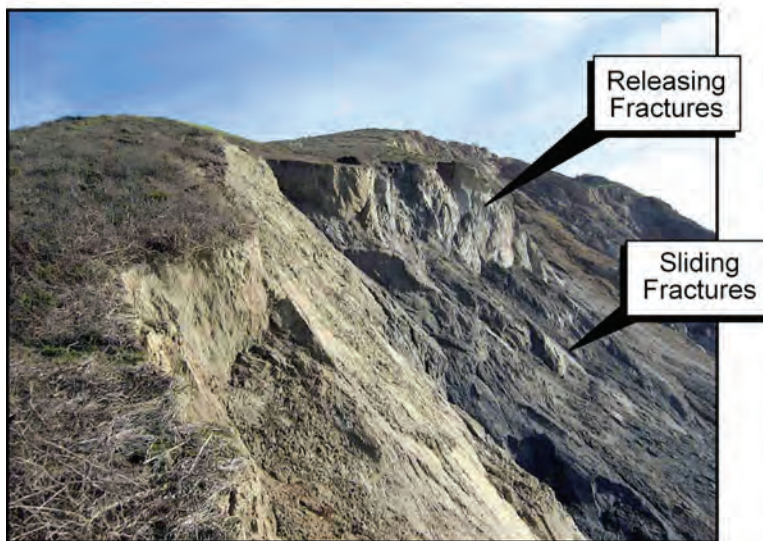
Figure 7. A block diagram and photograph showing sliding and releasing fractures identified during investigation of the landslide. Photograph by Dale R. Marcum.

The kinematics of the NBL are two-fold: initial deep-seated block failure in the upper bluff followed downslope by disaggregation and rapid flow. In the upper portion of the landslide, large blocks slowly begin to slide along sliding fractures and weak bedding planes while releasing fractures open as tension cracks. In the upper portion of the NBL, sliding is controlled by the location and orientation of these planes of weakness. Over time and with introduction of rainwater, these critically unstable blocks mobilize rapidly. The sedimentary bedrock appears to partially disaggregate as the failure accelerates and flow is initiated. The rapidly moving, fluid nature of this mass allowed it to flow across the beach and into the ocean approximately 100 meters from the bluff (Figure 4). Presently, the toe has been eroded back toward the original base of the coastal bluff as the surf rapidly eroded the landslide debris that extended beyond the bluff.

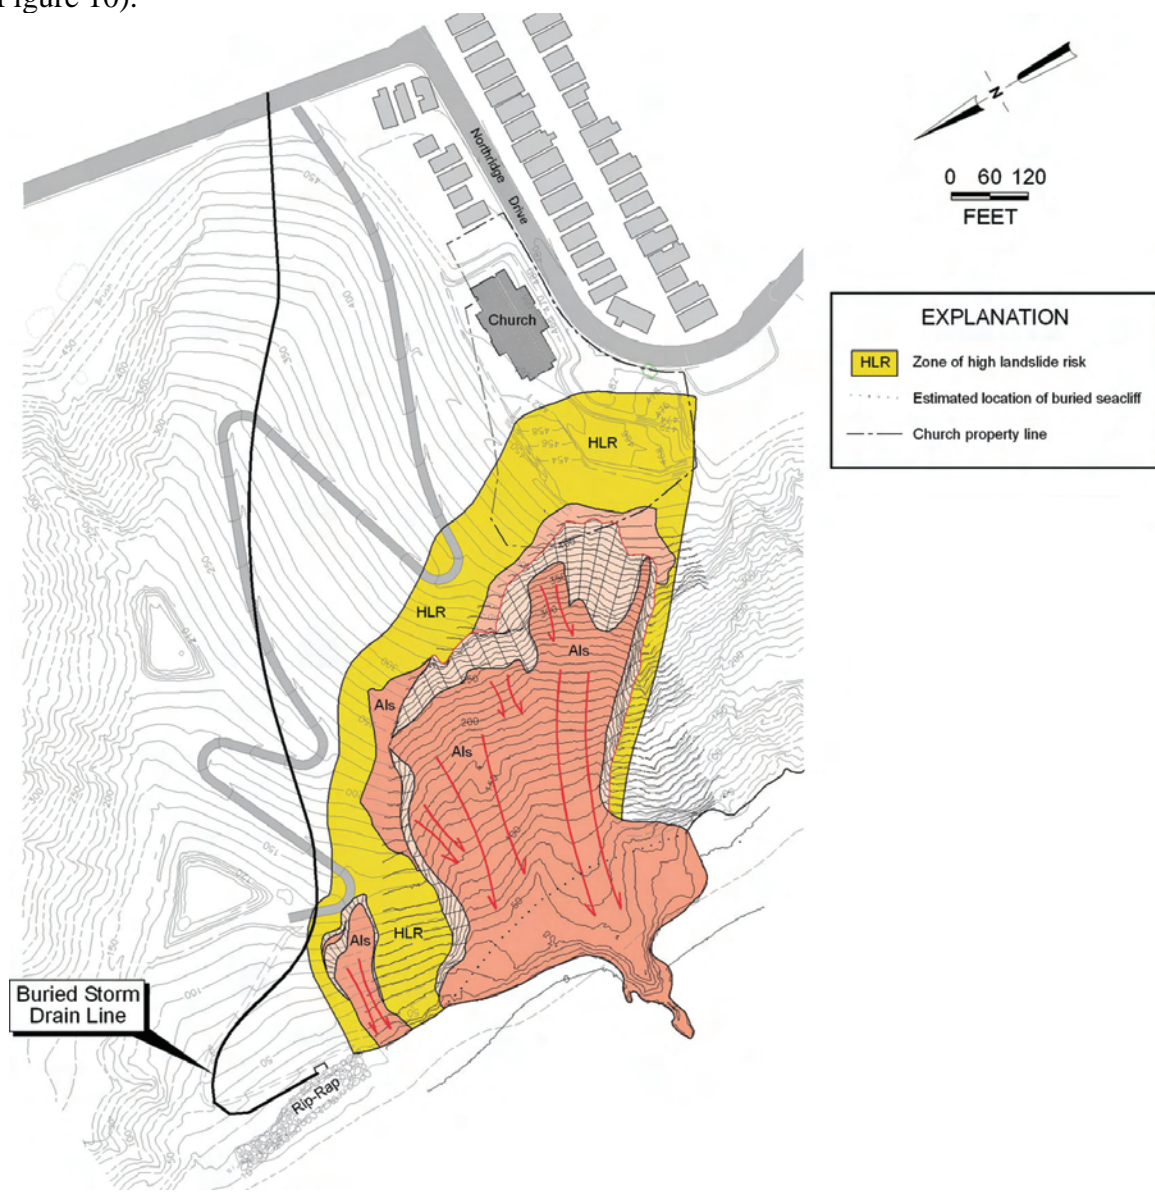
A major result of our investigation is the landslide hazard map (Figure 8), which defines a zone of high landslide risk. We established the perimeter of the zone by constructing a series of topographic profiles through critical slope locations. Then using

Figure 8. Landslide hazard map for the Northridge Bluff Landslide and surrounding area.

There is no reliable method by which we can define a timetable for failure of the unstable slopes in the high risk zone. At this site, the best estimate that can be offered is a qualitative forecast that the upslope progression of landsliding will extend into the high risk zone during the design life of the Avalon Canyon storm drain project north of the NBL and the church development located adjacent to the headscarp.

Land located immediately to the north and east of the Zone of High Risk, has a moderate landslide risk. Moderate risk is normally reserved for hillside regions that bound high risk regions and transition between high and low risk zones. The potential for enlargement of the landslide down-section from the stratigraphically controlled weak southern margin appears to be lower due to the relative stability of the resistant sandstone to the south and the weakness of the overlying sheared claystone.

Prior to development adjacent to coastal bluffs, the risk associated with bluff failure should be evaluated utilizing geologic characterization and detailed quantitative analyses to identify unstable geologic conditions and accurately evaluate the risk. These analyses should be performed to develop hazard maps and define meaningful setbacks prior to development of coastal sites.

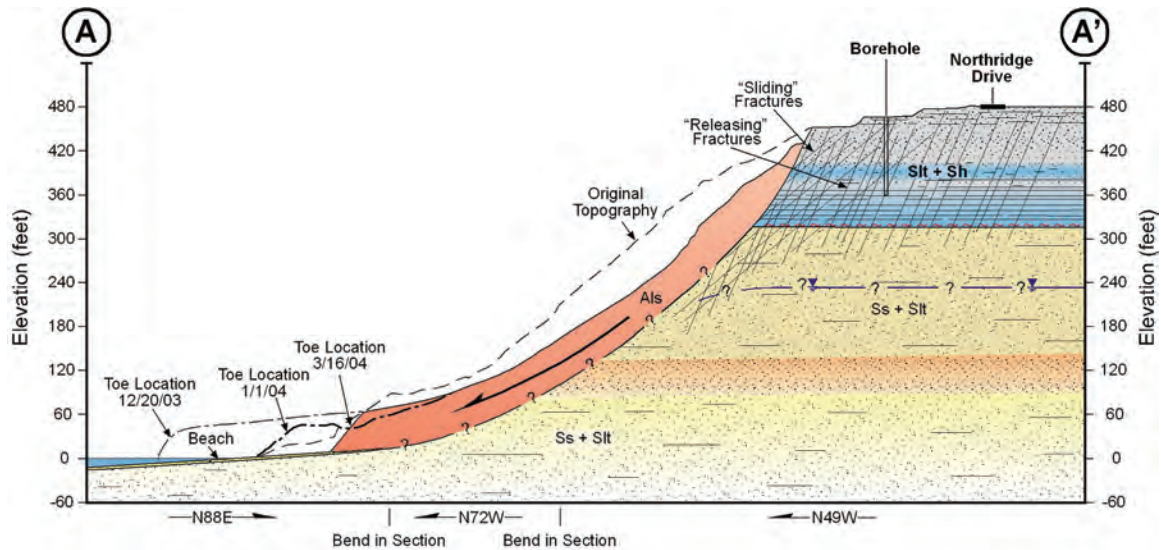
these profiles, we developed geologic cross sections through the landslide deposits and the headscarp regions (Figure 9). To establish the limits of the high landslide risk zone we estimated the subsurface geometry of the landslide basal rupture surface, measured the inclinations of those surfaces and projected them upslope to intersect the ground surface. The upslope projection of the potential failure surfaces along several profiles established points beyond the edge of the NBL that we believe define ground that is vulnerable to continued failure. These points typically ranged from 170 feet above the headscarp to about 90 feet along the north margin of the NBL. To compensate for the uncertainty in our evaluation, we increased these distances by 50% along the margins of the NBL to define the Zone of High Risk. We expect that additional landsliding along the margins of the NBL will be limited to this high risk zone (Figure 8). Failures within the headscarp region subsequent to our 2004 investigation have been limited to this zone (Figure 10).

Figure 9. Engineering geologic cross section A-A' through the Northridge bluff Landslide.

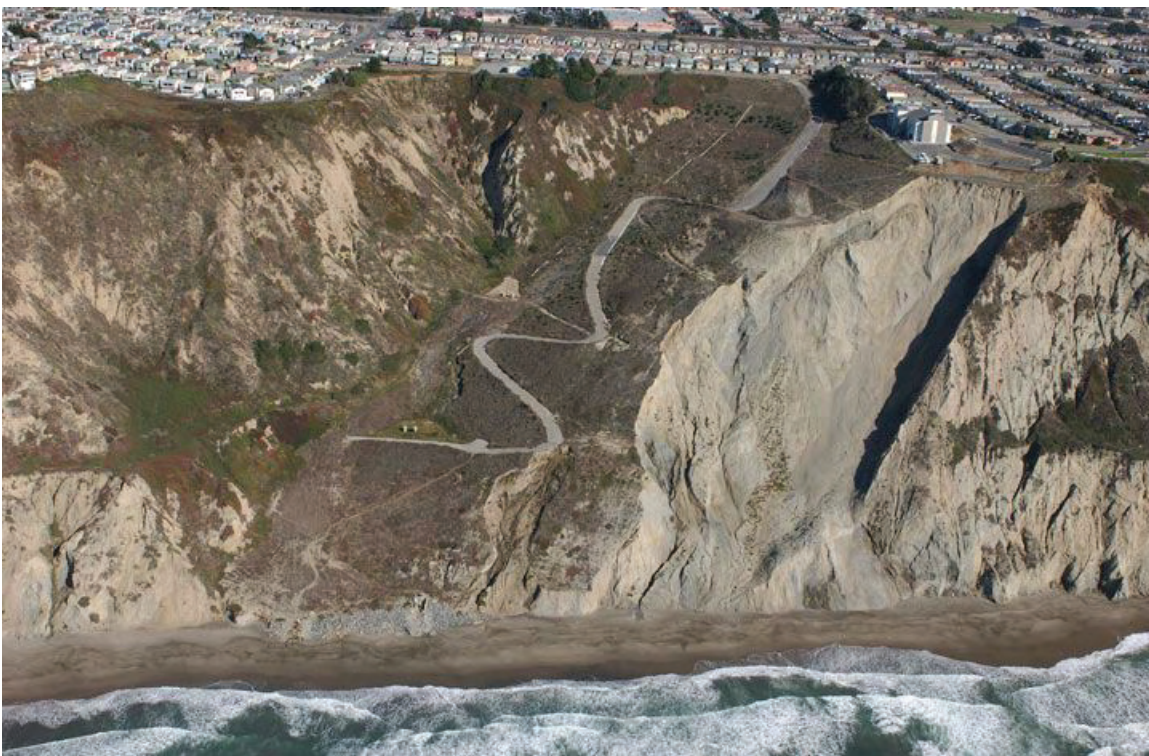
Figure 10. Aerial photograph of the landslide taken on October 5, 2005, after completion of the NBL investigation. Portions of the church property at the head of the landslide and blocks along the north margin have failed since landslide mapping was completed during 2004 (Figure 5). Note that a hairpin turn in the access road for the Avalon Canyon storm drain project was relocated in 2005, because slow, steady movement of headscarp blocks began to open releasing fractures and undermine a portion of the road. Published by permission of Kenneth and Gabrielle Adelman, California Coastal Records Project.
