UNSTABLE SLOPES IN THE FRANCISCAN COMPLEX TERRANE: LESSONS LEARNED FROM URBAN QUARRY SLOPES IN THE SAN FRANCISCO BAY AREA

Ted M. Sayre¹ & John M. Wallace²

¹*Cotton, Shires & Associates, Inc., Consulting Engineers and Geologists, 330 Village Lane, Los Gatos, CA 95030 (tsayre@cottonshires.com)*

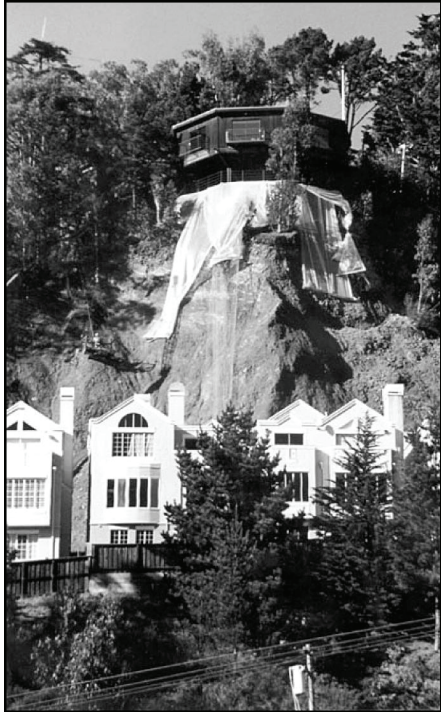
Figure 1. Newer residential development near base of Knockash quarry slopes.

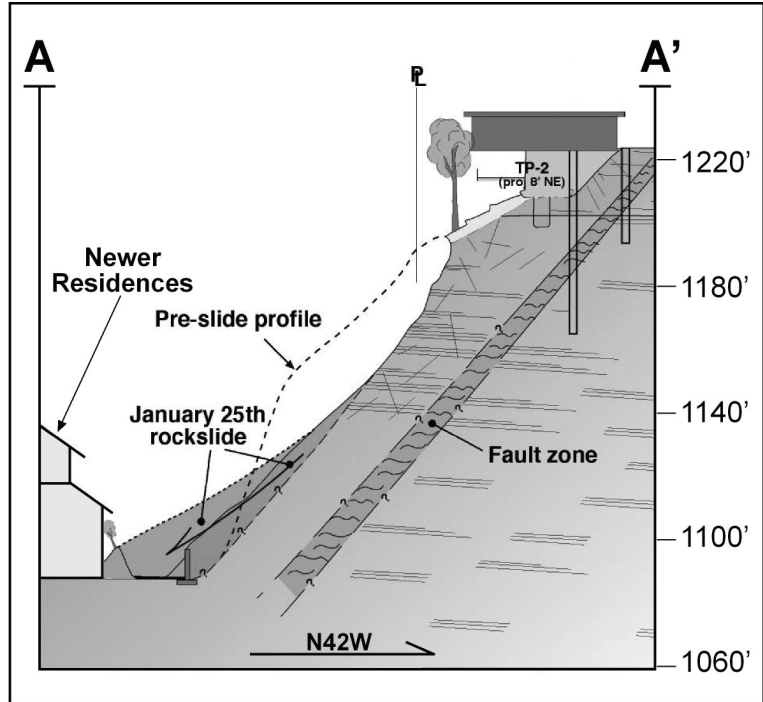
Figure 3. Geologic Cross Section through Knockash Quarry wall.

Two primary sub-units have been identified within the ribbon cherts, including thin-bedded chert (1 to 6 inch thick beds) with interbedded red shale (beds 0.25 to 3 inches thick), and thick-bedded green chert with little to no shale. Very hard, resistant, thick- and thin-bedded green chert forms the steepest upper portions of site slopes. The ribbon chert has a regional dip of approximately 20 to 40 degrees to the northeast, but locally has very tight Chevron folds. The chert beds are hard, moderately strong to strong, and closely fractured. The interbedded shale is generally soft to moderately hard, weak to moderately strong, and pulverized to closely fractured. Slake tests indicate that the shale is highly reactive and subject to very rapid loss of strength and deterioration when immersed in water. Rapid weathering of exposed shale interbeds appears to contribute to surface weathering that may help explain the significant average annual slope face retreat observed in aerial photographs over several decades.

Our observations and analysis indicated that the oversteepened quarry face had the potential to fail in several modes including as a shallow rockslide, a deep-seated rockslide, a rock topple, and a debris slide of talus and quarry debris. The primary factors responsible for rockslide failure within the ribbon chert appear to be: 1) the oversteepening of the rock mass due to quarrying; 2) exposure of ribbon cherts with slake prone shale interbeds; 3) the presence of a slope parallel shear zone 30 to 40 feet below the ground surface; and 4) intense rainfall episodes. Rapid slaking and swelling of the exposed shales results in accelerated weathering, fracturing, and dilating of the rock mass. The areas most susceptible to rocksliding appear to be those oversteepened slopes underlain by ribbon cherts that have high shale to chert ratios (between 25% and 50%).

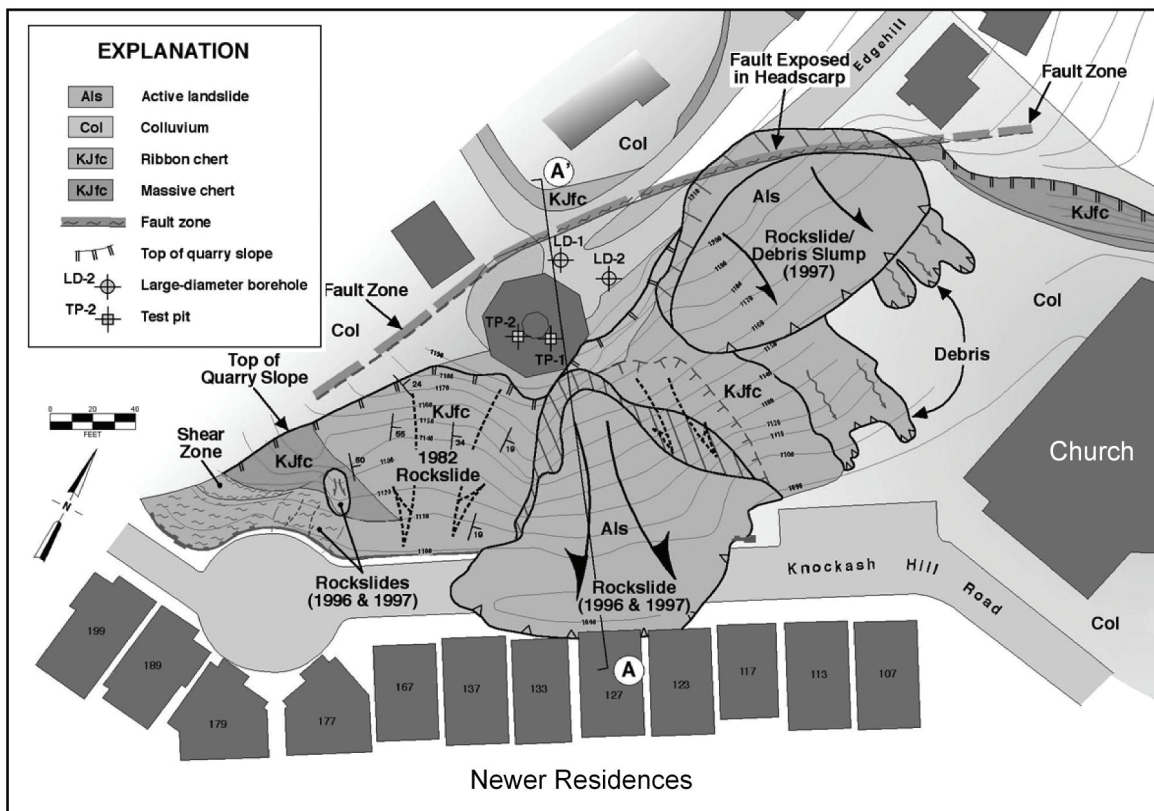
Figure 2. Knockash development Geologic Map.

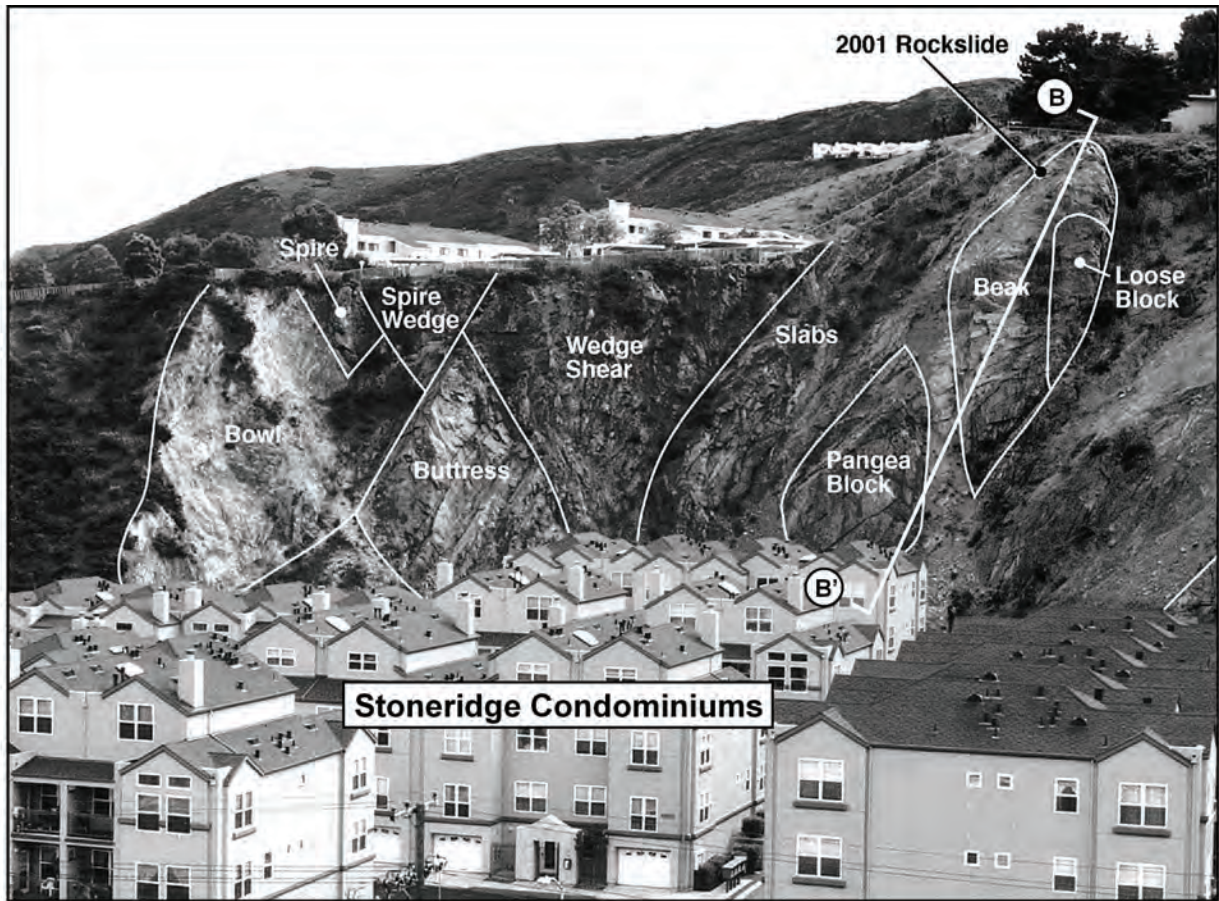
Figure 4. Stoneridge development within former quarry site.

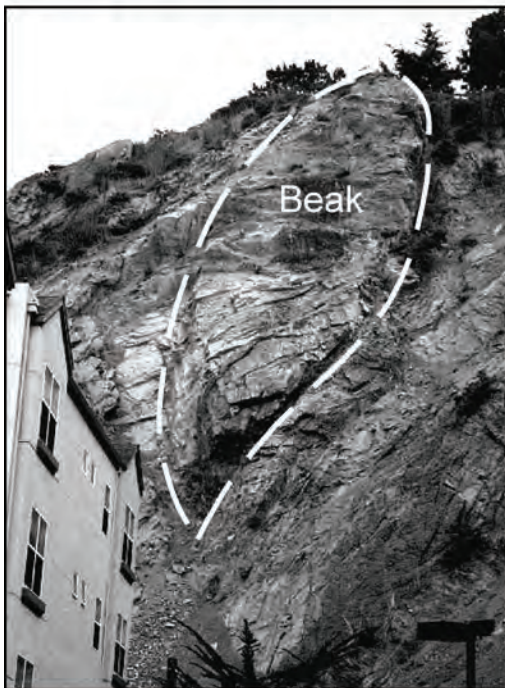
Figure 5. Large sandstone block perched above building.

Shallow rockslides and rockfalls are relatively common along the upper portions of the quarry slopes, and were responsible for the December 2001 Stoneridge evacuation. The site investigation revealed the potential for deep rocksliding of large resistant sandstone blocks, such as a large block referred to as 'The Beak' that was identified during our detailed geologic mapping (Figure 5). The Beak has a calculated volume of approximately 1,000 cubic yards and has not been exposed to violent seismic ground shaking to date. During the 1989 Loma Prieta earthquake, the site likely experienced maximum ground accelerations of approximately 0.10 to 0.15g (Borchert and Holzer, 1994). The property is located approximately 4.6 miles from the active San Andreas fault and mean peak horizontal accelerations of at least 0.5g are anticipated (Sadigh, 1997). Dynamic site response could potentially result in topographic amplification and maximum rock accelerations near the rim of the quarry exceeding 1.0g. Considering that The Beak displays evidence of recent movement, we concluded that this block has a high potential to fail during a nearby strong seismic event thereby exceeding the capacity of the existing catchment fence (Figure 6).

To reduce the hazards to residential facilities at the toe of the slope, we recommended in 2005 that supplemental mitigation measures be implemented including additional light scaling of select slopes, installation of an additional 20 tensioned, double corrosion protected rock anchors (50 kip capacity) to secure a large incipient block failure (The Beak), application of wire mesh slope netting on select slopes to reduce rock bounce heights, and adoption of a periodic inspection schedule to monitor slope conditions and the performance of installed mitigation measures. Total estimated cost for the completion of supplemental recommended mitigation measures was \$700,000 in early 2005.

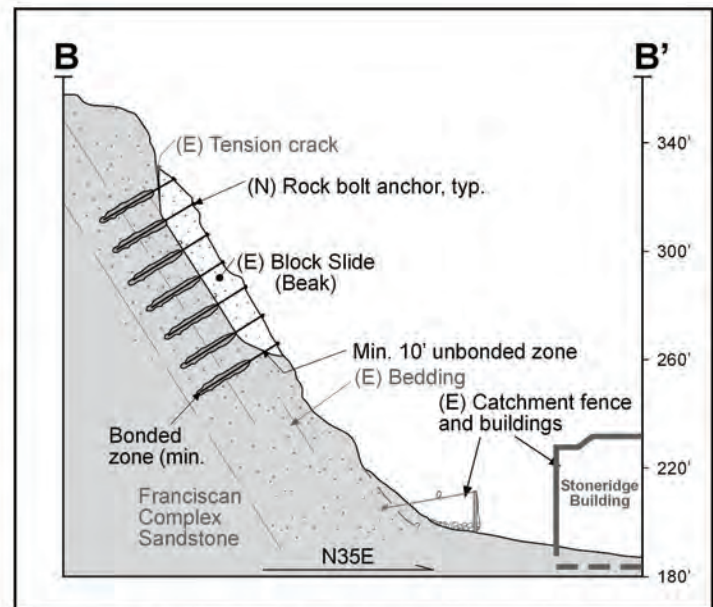
Figure 6. Geologic Cross Section through Stoneridge quarry wall.
