**MITIGATION OF 1998 EL NIÑO
SEA CLIFF FAILURE,
PACIFICA, CALIFORNIA**

**PATRICK O. SHIRES, TED SAYRE
and DAVID W. SKELLY**

COTTON, SHIRES & ASSOCIATES, INC.
CONSULTING ENGINEERS AND GEOLOGISTS

ARTICLE REPRINTED FROM:
ENGINEERING GEOLOGY PRACTICE
IN NORTHERN CALIFORNIA (2001): EDITED BY
HORACIO FERRIZ AND ROBERT ANDERSON, PAGES 607 - 618.

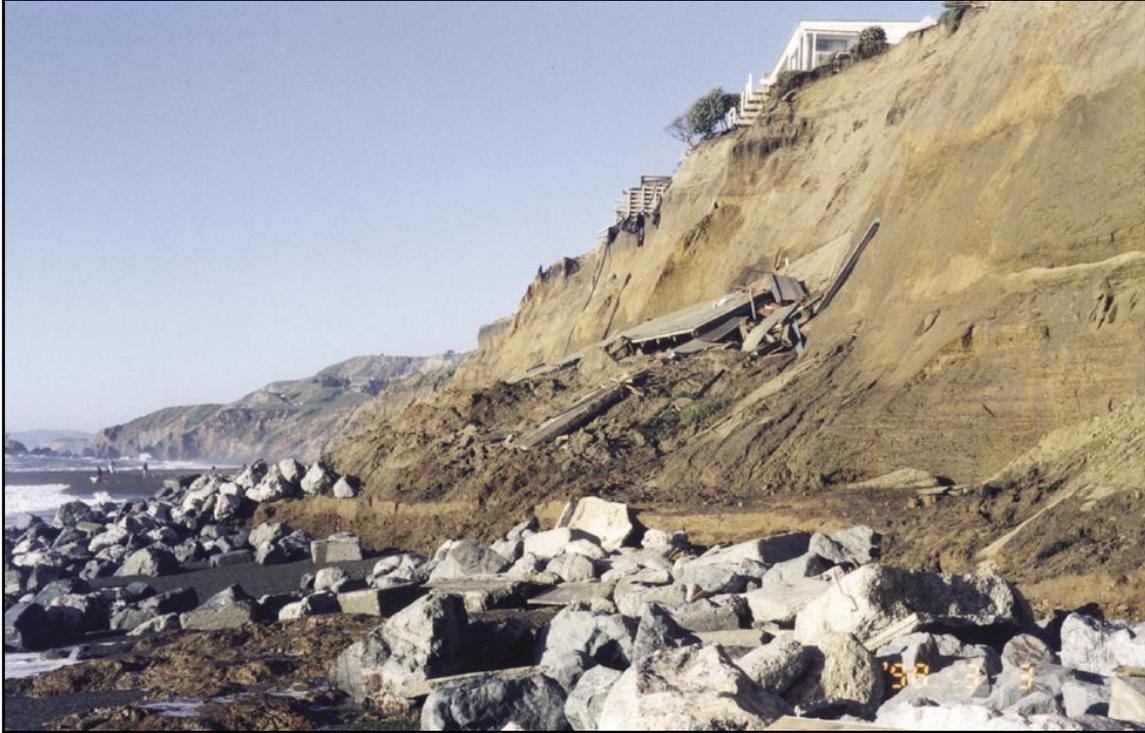
Figure 3. Remnants of previous rock revetment scattered across the beach after the 1998 El Niño event.

El Niño event, a homeowners group in cooperation with the City of Pacifica funded construction of a rock revetment. The lack of adequate maintenance, coupled with adverse design aspects (rock size was relatively small and apparently not keyed into bedrock materials), resulted in a short life-span for this structure. Although relatively intact sections of this revetment were still visible in 1996, by March 1998 the earlier revetment had been reduced to an irregular scattering of boulders across the narrow sandy beach (Figure 3).

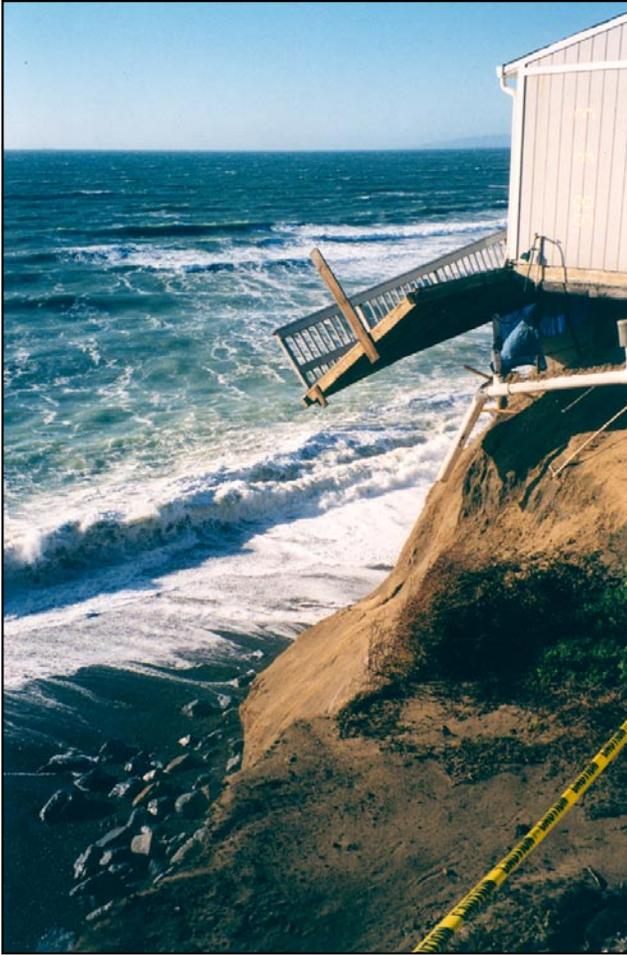
Figure 7. Offshore wave height may exceed 20 feet and wave surge from shore break attacks the base of coastal bluffs during high tides.

In general, high waves in combination with high water levels locally result in erosion of beaches and wave attack at the base of the coastal bluffs (Figure 7). At this site, offshore wave heights exceeding 20 feet are not uncommon during winter storms. However, the design wave condition for a shoreline structure is generally not the largest wave, because the largest waves break offshore in water depths approximately equal to the wave's height. The largest "*design wave force*" will occur when a wave breaks directly on the shoreline structure. The largest wave that can break on the revetment is determined by the depth of water at the toe of the structure. Using the water depths defined earlier, the resulting design wave heights are 10.0 feet for the 50-year recurrence interval and 12.0 feet for the 100-year recurrence interval. Incoming wave periods vary from 9 to 20 seconds. A design period of 20 seconds was selected because this period wave would produce the highest run-up.

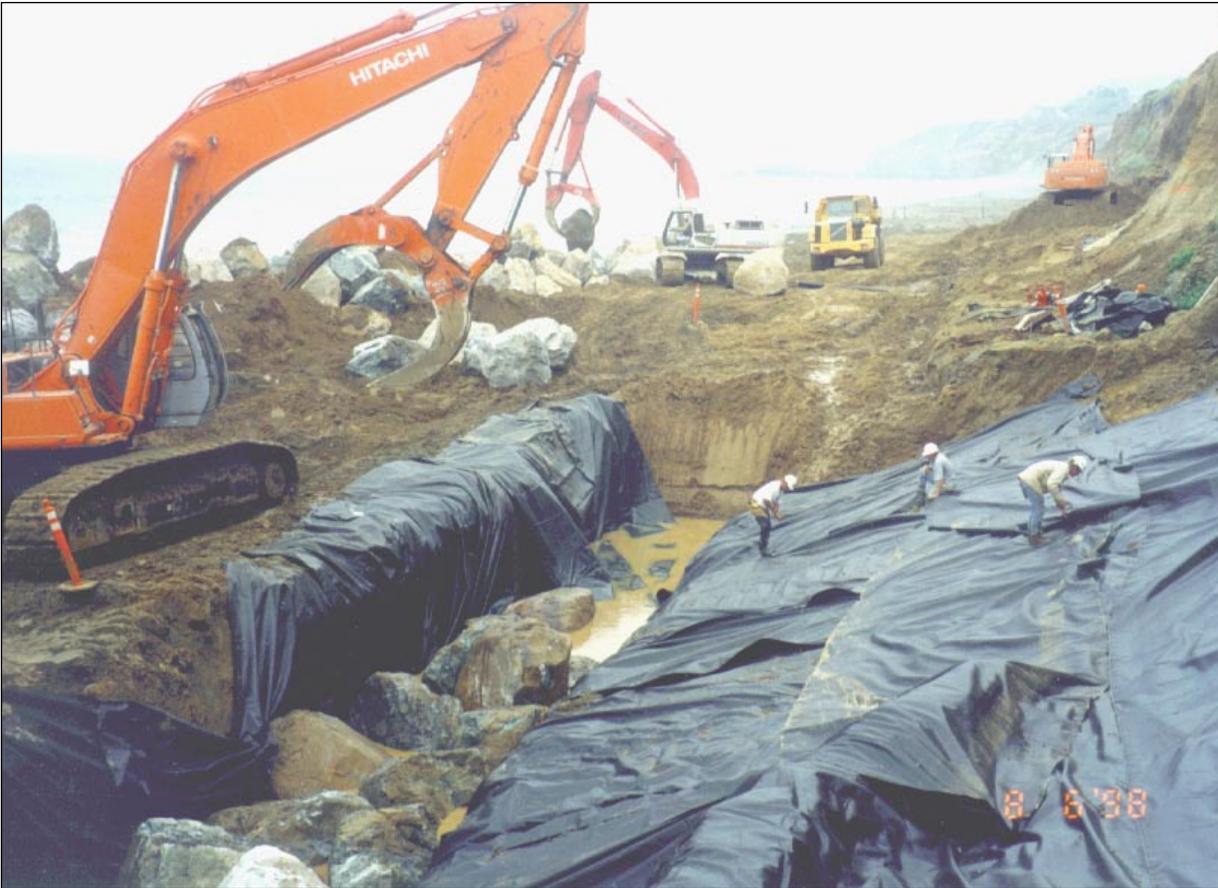
Figure 8. Filter fabric is being placed in the keyway and along the base of the revetment prior to stone placement.

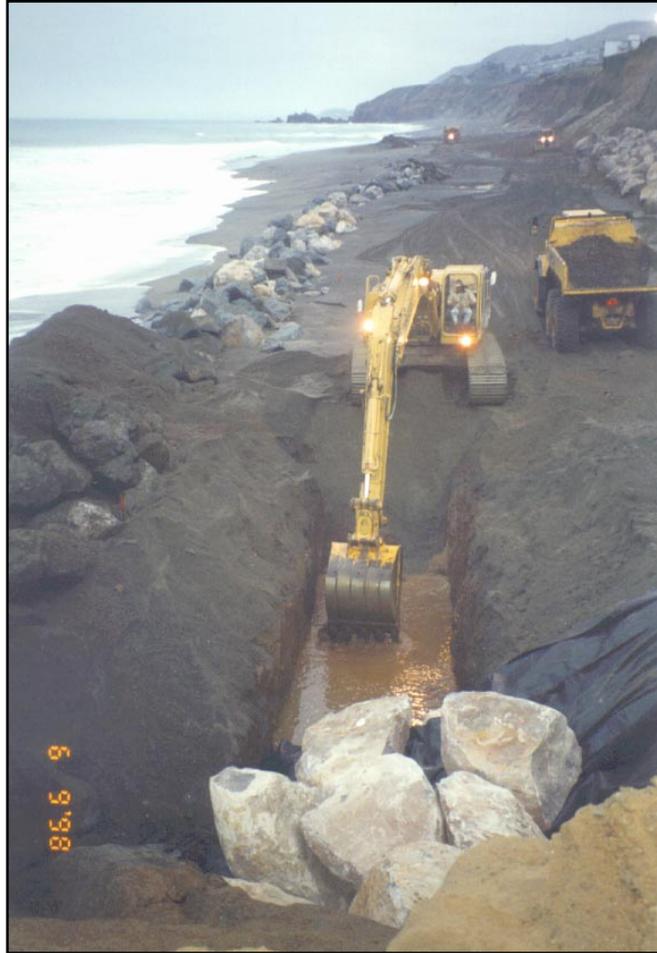
Figure 9. Keyway excavation below mean sea level required strategic construction timing with respect to tidal conditions.

Trucks delivering armor stones to the site would typically accommodate only two large stones per load, with possibly room for a few smaller core stones. Because the keyway for the revetment was to extend into Franciscan bedrock located below mean sea level, stone placement was possible only during periods of low tide (Figure 9). Sufficient stone for the construction of a 100-foot segment of the revetment was delivered to a staging area high on the beach, and placement of rock into the keyway (excavated the previous day) occurred during low tide.
