Geologic and Geotechnical Factors Controlling Incipient Slope Instability at a Gravel Quarry, Livermore Basin, California

PHILIP L. JOHNSON¹
PATRICK O. SHIRES
TIMOTHY P. SNEDDON

Cotton, Shires and Associates, 330 Village Lane, Los Gatos, CA 95030

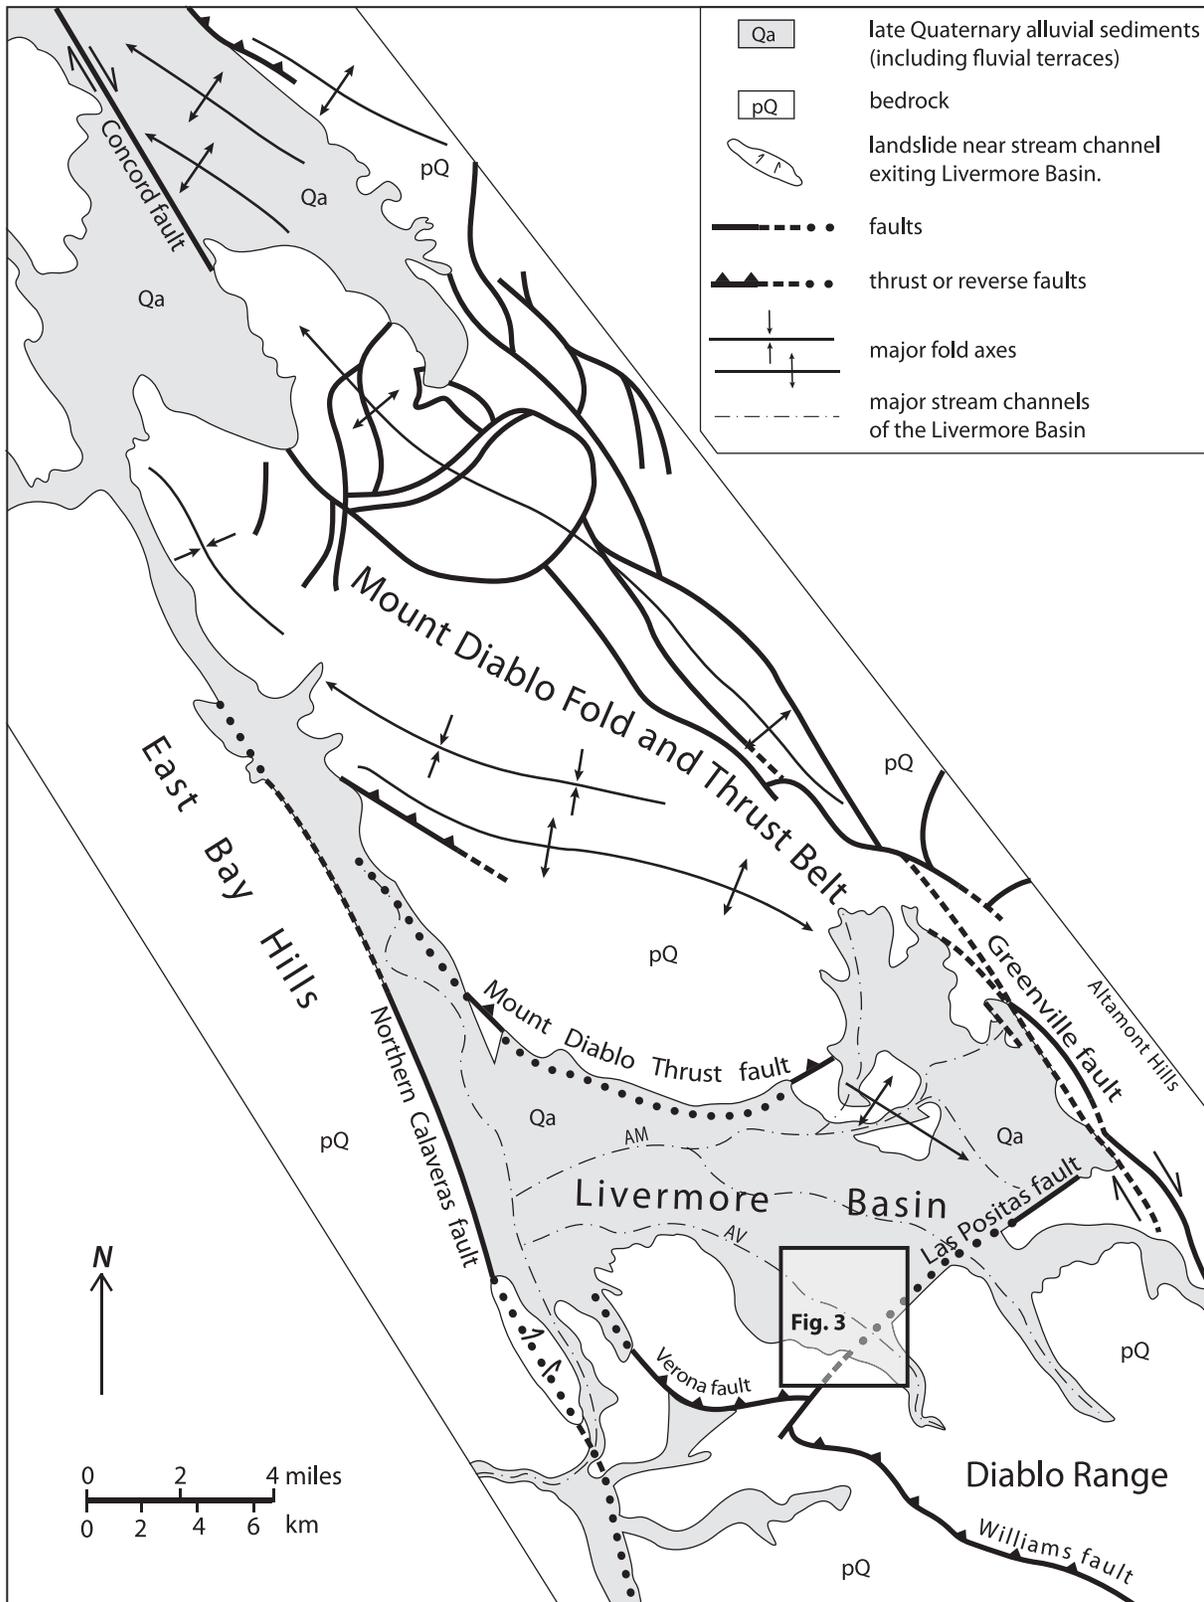
Figure 2. Simplified map of the Livermore Basin and major mapped faults, modified from Wagner et al. (1990). The labeled primary stream channels within the basin are Arroyo del Valle (AV) and Arroyo Mocho (AM).

The roughly east-west-trending late Quaternary Livermore Basin (Figure 2) is filled with non-marine clastic sediments (Barlock, 1989; Helley and Graymer, 1997). During Miocene to early Pleistocene time, the ancestral Livermore Basin (Unruh et al., 1997) extended beyond the limits of the late Quaternary basin, and upper Miocene to lower Pleistocene sedimentary rocks of the Sycamore, Tassajara, and Livermore formations are exposed in the hills that surround the late Quaternary basin (Andersen et al., 1995). The sediments that fill the late Quaternary Livermore Basin consist of Pleistocene to Holocene alluvial fan,

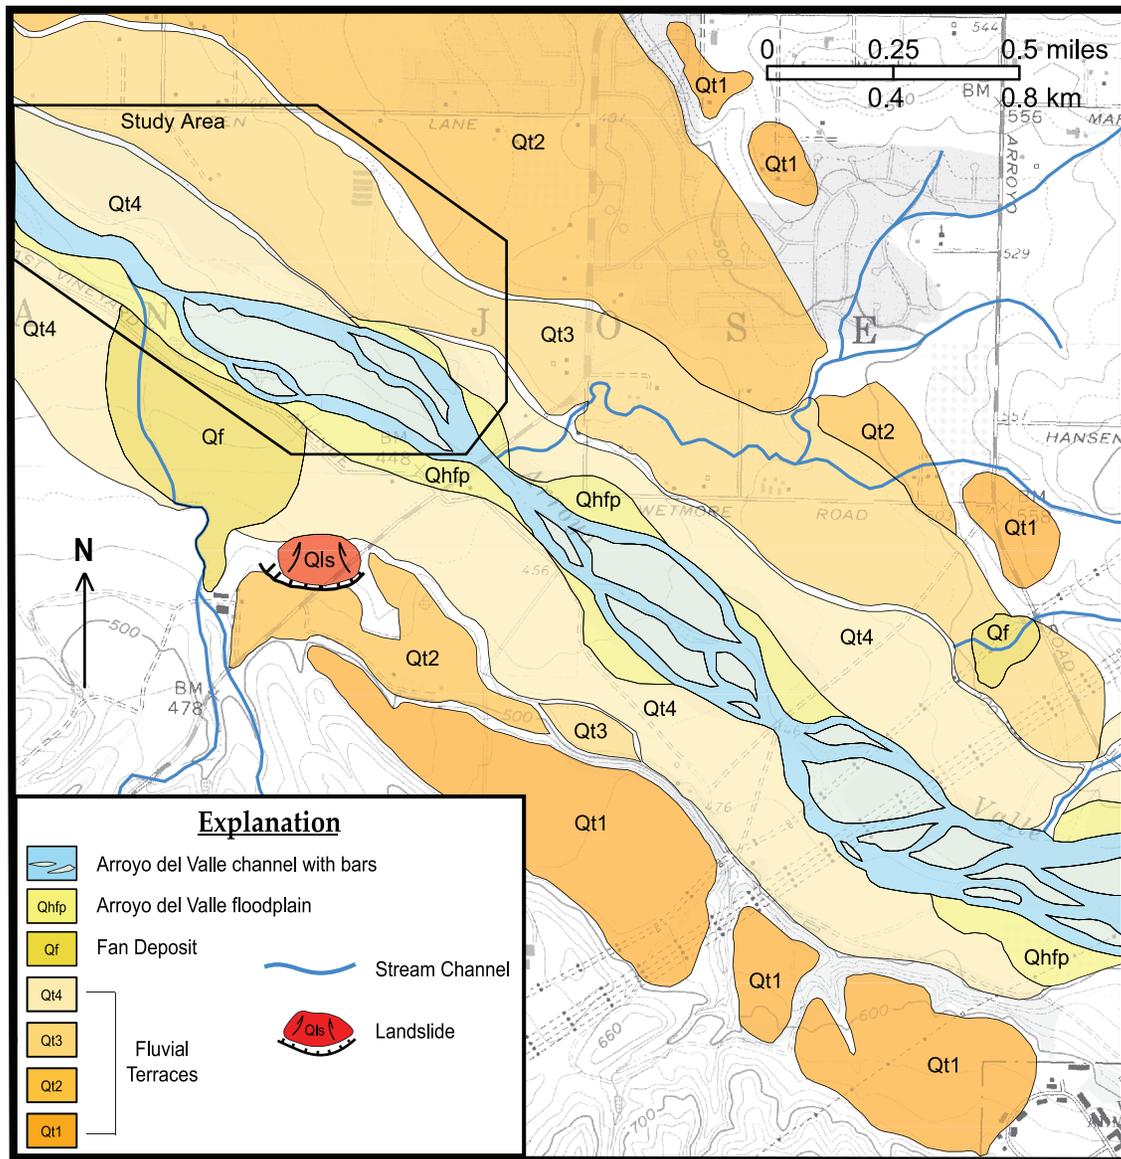
Figure 3. Photogeologic map showing the geomorphic setting of the Arroyo del Valle Quarry area, based upon interpretation of stereo pairs of historic aerial photographs. The polygon in the upper left portion of the map shows the area of Figure 7.

The geomorphology of the Arroyo del Valle Quarry site and surrounding area was mapped using stereo pairs of historic aerial photographs that pre-date the excavation of the quarry (Figure 3). The geomorphic

setting of the southern Livermore Basin was shaped by fluvial deposition along Arroyo del Valle, a low-sinuosity (braided) stream. The stream channel is flanked by uplifts to the northeast and southwest. To the northeast, a subdued intrabasinal uplift is centered on the Livermore anticline that may be associated with a blind reverse or thrust fault (Sawyer and Unruh, 2004). To the southwest, tilted beds of the Livermore Formation flank the southwest margin of the basin. Between these two uplifts, Arroyo del Valle flows toward the northwest. A series of fluvial terraces ascend from the channel of Arroyo del Valle (youngest to oldest) and up the flanking uplifts northeast and southwest of the channel (Figure 3). The Arroyo del

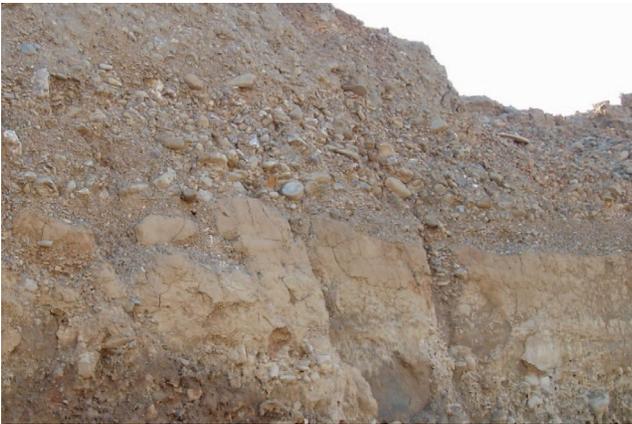
Figure 4. Sandy gravel over a fine-grained bed exposed in the shallow portion of the quarry pit wall.

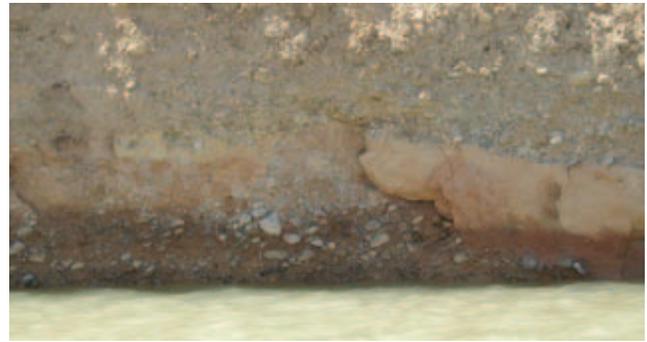
Figure 5. A fine-grained bed that pinches out laterally (exposed in the quarry pit wall).

Interbedded with the sandy gravel are local beds of yellowish brown (10YR) clayey silt to silty clay that are generally less than 6 ft (2 m) in thickness (Figure 5). Based upon subsurface exploration, local fine-grained beds within the sandy gravel are mostly discontinuous, and where correlation of individual beds can be accomplished between boreholes, they appear to be horizontal or subhorizontal.

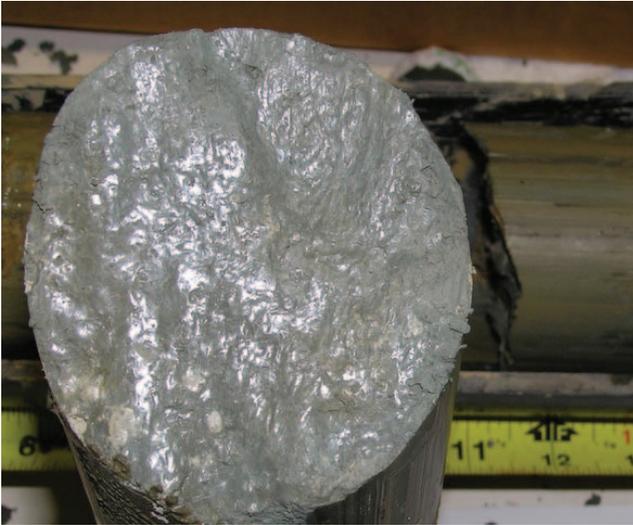
Figure 6. A core sample exposing a polished surface within the sheared unoxidized clay.

The sheared, unoxidized clay and underlying marl form a distinctive and laterally persistent stratigraphic couplet. This couplet was traced across the quarry site and adjacent area to the northeast and is designated as the unoxidized clay-marl marker bed couplet.

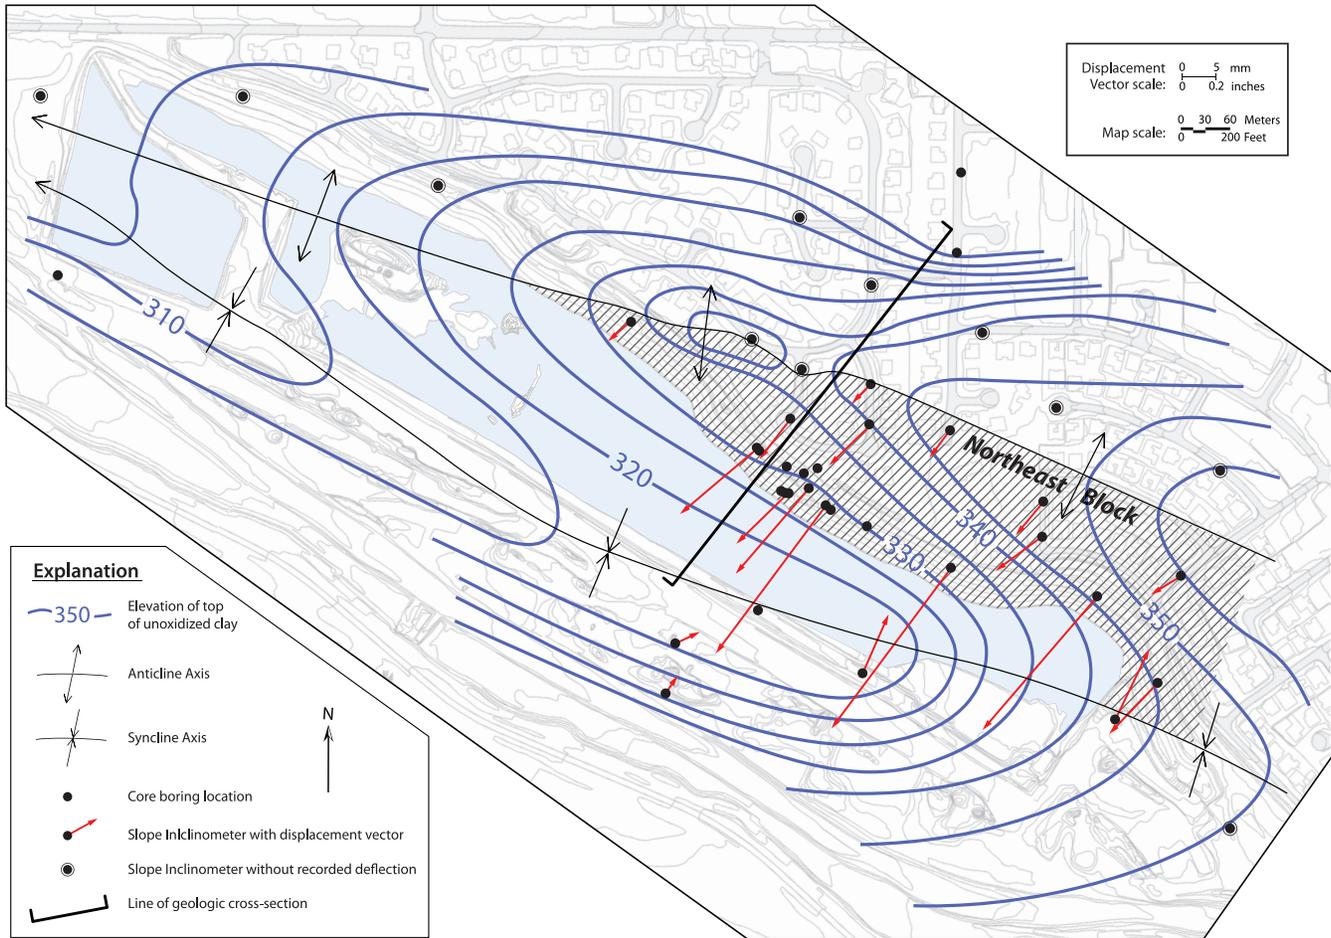
Figure 7. Site map with structure contours drawn on the top of the unoxidized clay-marl marker bed couplet. The cross-section line indicates the location of the geologic cross section (Figures 8, 9, and 13).

correlation of the marker bed couplet between these borings, structure contours were drawn on the top of the marker bed couplet (Figure 7). The structure contour map shows a northwest-plunging anticline in the northern portion of the study area and a northwest-plunging syncline in the southern portion. These folds align well with the orientation of other folds and thrust faults in the MDFTB. This implies that folding of the lacustrine sediments is related to northeast-southwest shortening within the MDFTB.

Slope instability is also controlled by geologic structure. As shown in Figure 7, the slope inclinometer

displacement vectors are consistently oriented in a down-dip and downslope direction. At the northeast margin of the quarry, in the area between the anticline axis (Figure 7) and syncline that underlies the pit floor, slope inclinometer monitoring data show deflections in a down-dip direction, toward the pit. We refer to this critical sliding block where the sheared unoxidized clay dips toward the quarry pit as the Northeast Block. The anticline axis that forms the updip margin of the Northeast Block acts as a natural barrier to retrogressive movement farther to the northeast. Across the anticline axis, the sheared unoxidized clay bed dips away from the pit slope, and the slope inclinometers on this fold limb have not deflected.

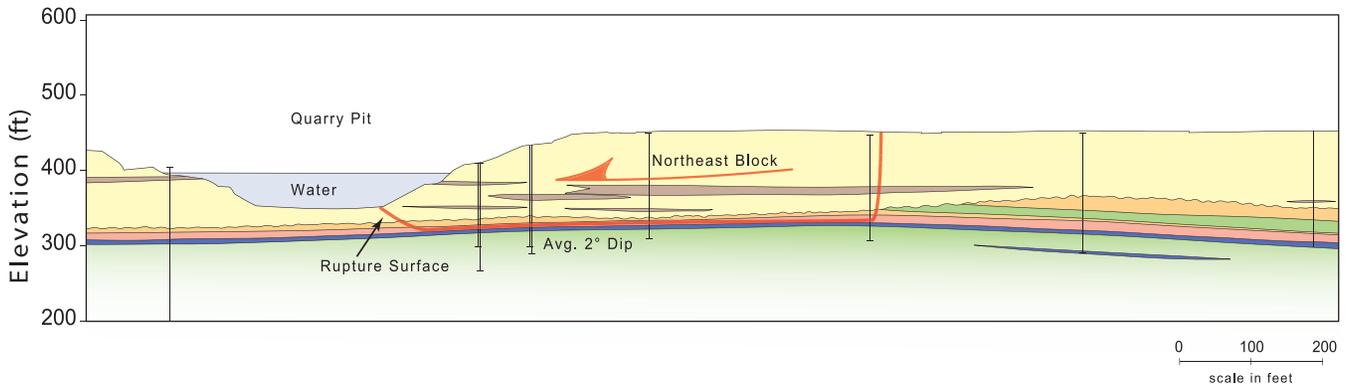
Figure 8. Geologic cross section across the quarry site and adjacent area northeast of the quarry.

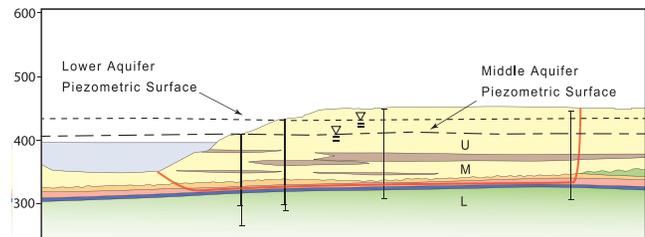
Figure 9. Hydrogeologic cross section showing the piezometric surfaces of the middle and lower aquifers within the Northeast Block. U, upper aquifer; M, middle aquifer; L, lower aquifer.

Long-term monitoring of vibrating wire piezometers installed in the lower aquifer indicates that piezometric surface elevations typically ranged from 75 to 102 ft (23–31 m) above the top of the lower aquifer. By contrast, the middle aquifer water levels have remained lower than those in the lower aquifer. Thus, the piezometer data indicate an upward gradient from the lower aquifer to the middle aquifer (Figure 9). Pore pressure measurements from piezometers installed in the unoxidized clay are intermediate between those of the middle and lower aquifers. This upward pore pressure gradient has caused elevated pore pressures within the intervening unoxidized clay interval.

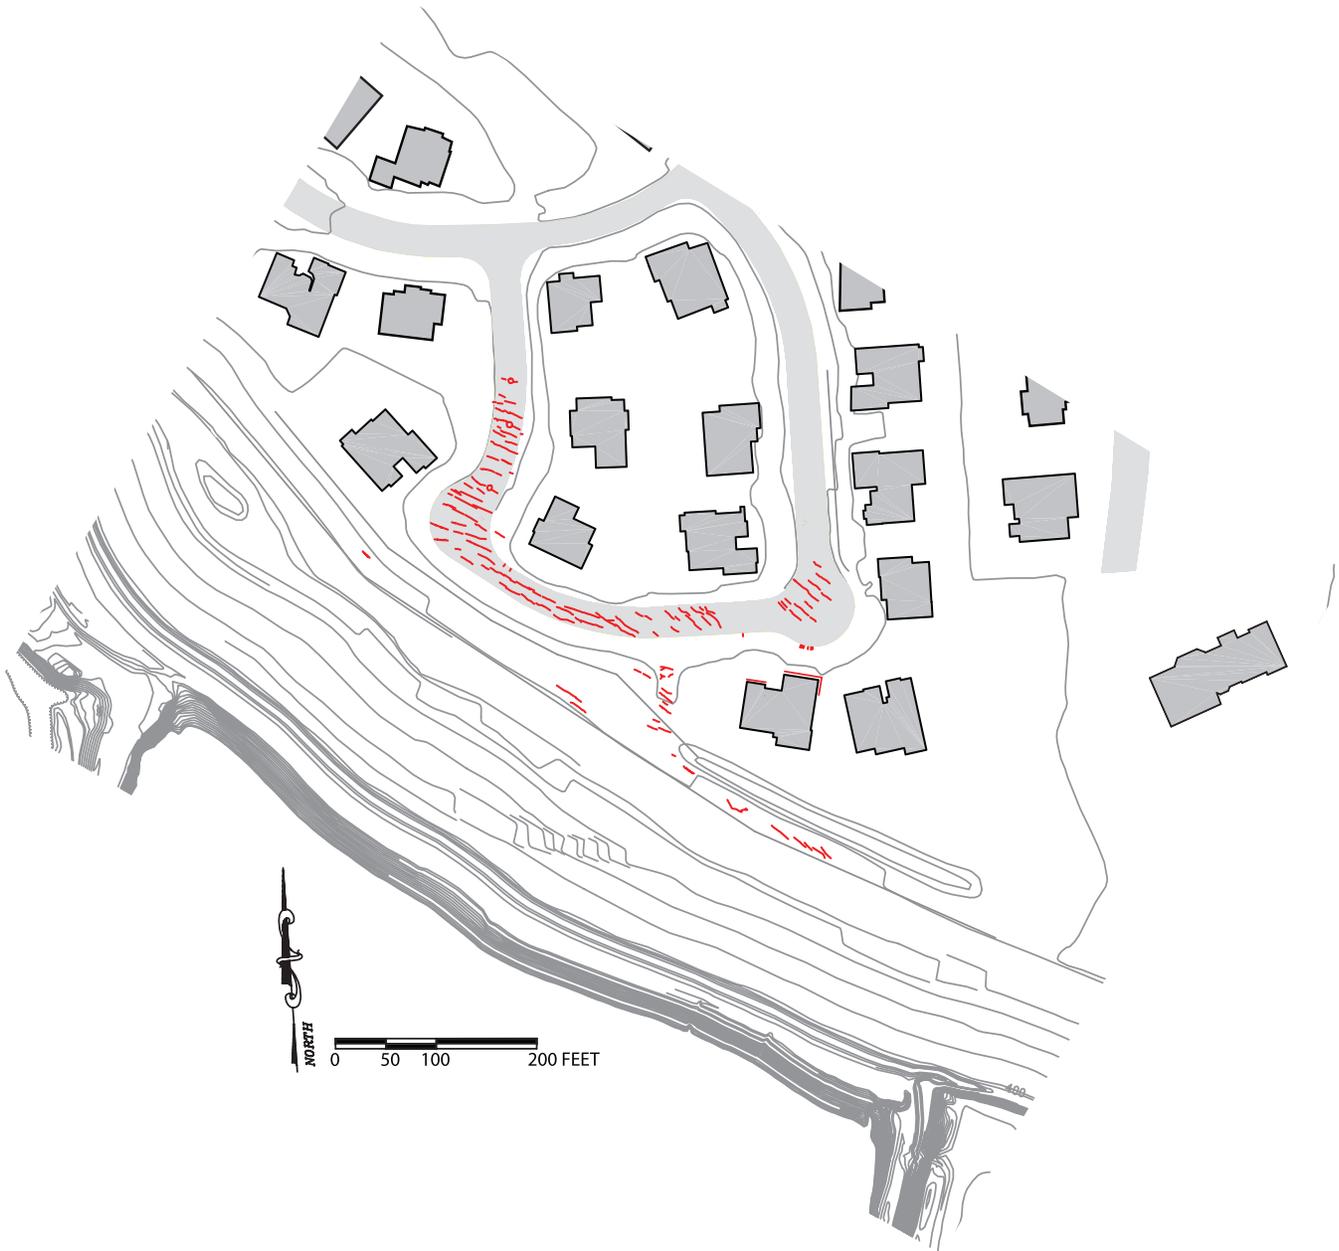
Figure 10. Map of ground cracks that were the first indication of incipient slope instability related to the quarry pit slope.

the quarry slopes came from linear cracks that formed in roadways located approximately 125 ft (38 m) northeast of the quarry pit (Figure 10). Following the initial observation of pavement distress in 2001, multiple slope inclinometers were installed around the quarry pit from 2002 to 2006.

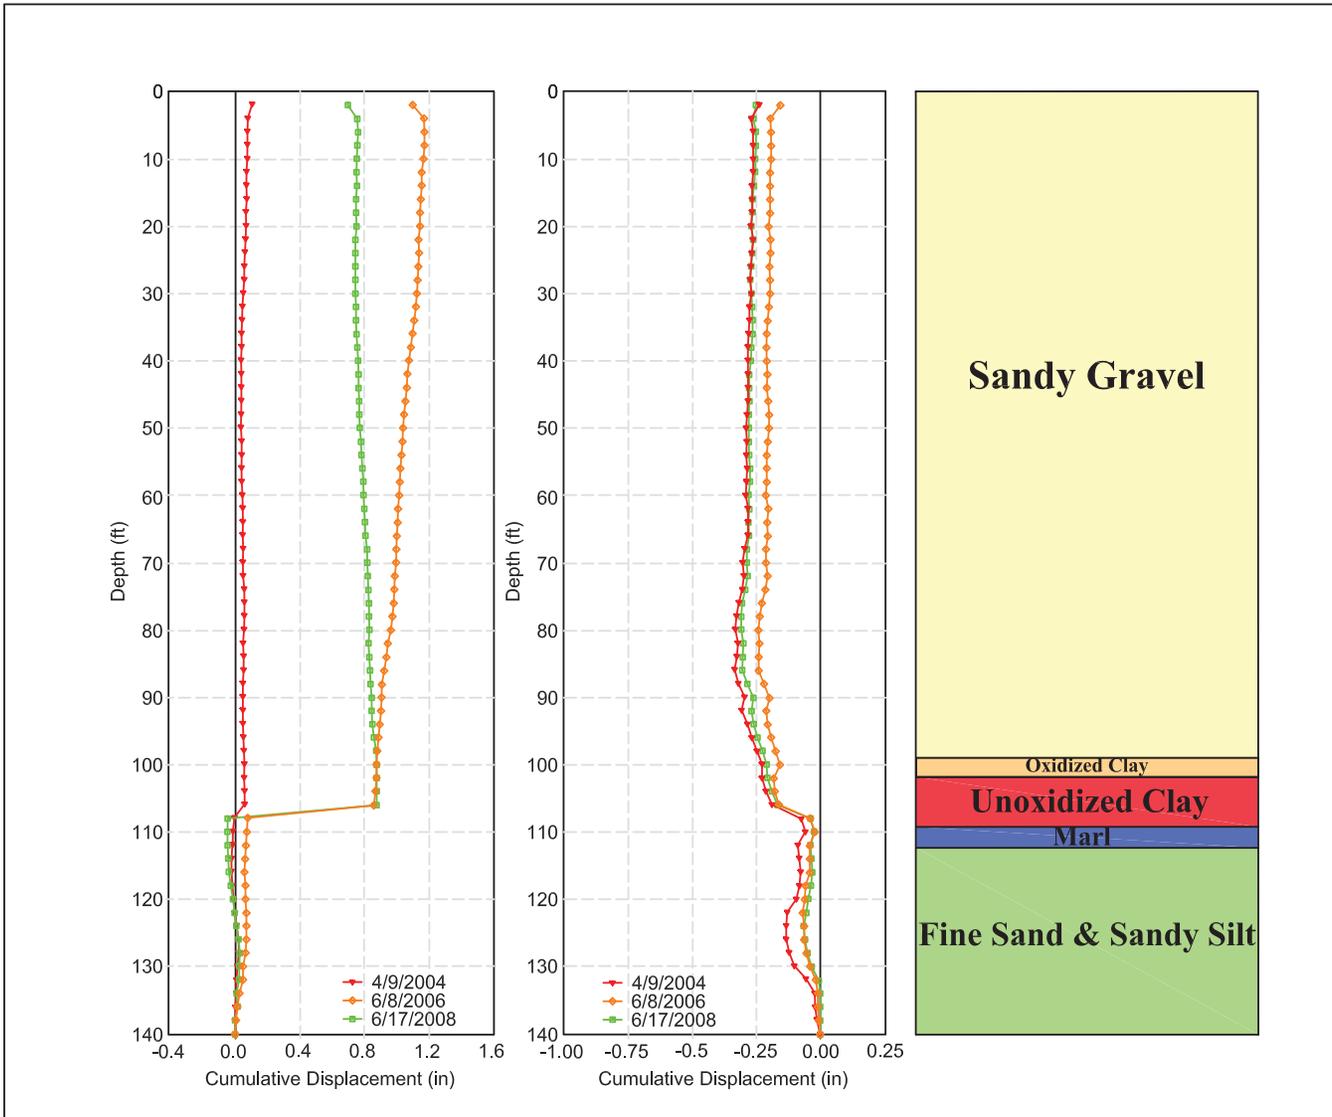
Figure 11. Slope inclinometer data plot and stratigraphic column from a slope inclinometer located near the northeast flank of the quarry pit.

Based upon detailed logging of continuous core samples from the slope inclinometer borings, discrete (landslide-type) deflections in the slope inclinometers were consistently found to correspond to the depth of the sheared unoxidized clay. This is shown in a data plot from a slope inclinometer located near the northeast flank of the quarry pit combined with the stratigraphic column from the same slope inclinometer boring (Figure 11). Even where the quarry pit walls were locally steeper than 2H:1V (26.6°), the slope inclinometer casings deflected only within the unoxidized clay and not within the upper sandy gravel sequence. Thus, the site stratigraphy exerts strong control on the instability of the quarry slopes.

The monitoring results from a representative slope inclinometer located on the upper bench on the northeast side of the quarry provide a useful record of displacement of the northeast block over a period of several years (Figure 12), although it does not include the estimated several inches of movement that occurred prior to slope inclinometer installation. For the purposes of this study, the rates of displacement were averaged and annualized to allow meaningful comparison of monitoring periods of varied durations. Between January 2004 and April 2005, slope

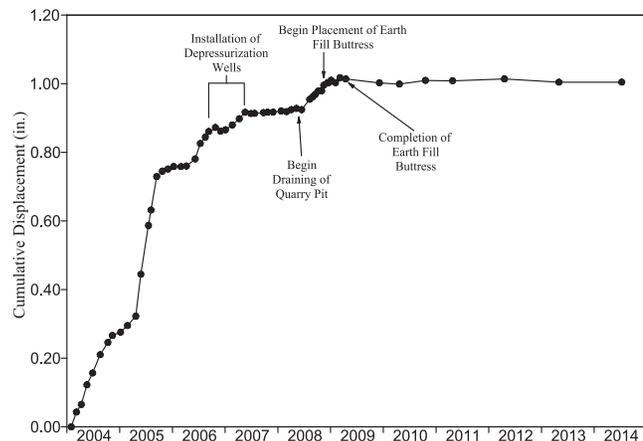
Figure 12. Graph of cumulative displacement over time at the unoxidized clay interval from a representative slope inclinometer on the northeast flank of the quarry pit.

inclinometer monitoring results showed that the displacement rates averaged 0.26 in. (6.6 mm) per year. Between April and September of 2005, the displacement rate increased to an average of 1.0 in. (25.4 mm) per year. Between September 2005 and September 2006, an average displacement rate of 0.14 in. (3.5 mm) per year was recorded. Thus, prior to implementation of mitigation measures designed to address slope instability at the quarry pit, the rate of movement within the Northeast Block had already slowed.

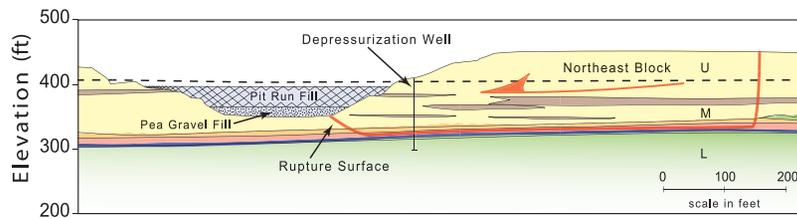
Figure 13. The geologic cross section annotated to show the phases of grading during placement of the earth-fill buttress. The depressurization wells are screened in the lower aquifer. U, upper aquifer; M, middle aquifer; L, lower aquifer. The dashed horizontal line represents the elevation of the lower aquifer piezometric surface after installation of the depressurization wells.

nearby roads and later by the slope inclinometers. Using partially mobilized upper gravel strengths, piezometric influence from the lower aquifer, and potential movement that extends northeastward to the anticline axis, our analysis showed that an industry-accepted static FS of greater than 1.5 and seismic displacements of less than 15 cm (6 in.) could be achieved by partial filling of the quarry pit with engineered fill to an elevation of 390 ft (119 m) above sea level (Figure 13).

In order to temporarily stabilize the Northeast Block before the quarry pit was fully drained, a temporary buttress was placed on the lake bottom. The temporary buttress consisted of pea gravel fill that was dropped through the water column and onto the lake bottom using a floating conveyor belt system. Figure 13 shows the buttress in cross-section view. Prior to construction, analysis of the loose dumped pea gravel fill indicated that it could be susceptible to liquefaction associated with strong seismic ground motions, so it was necessary to compact the pea gravel fill to provide long-term stability under future seismic loading conditions. Once the lake was drained and the pea gravel fill could be dewatered, it was excavated in slots oriented perpendicular to the slope and not more than 100 ft (30 m) wide in order to preserve the buttressing effect. The pea gravel was placed back

into the slots in lifts and compacted to 95 percent relative compaction. After recompaction was completed, the elevation of the top of the pea gravel fill was 364.5 ft (111.1 m).

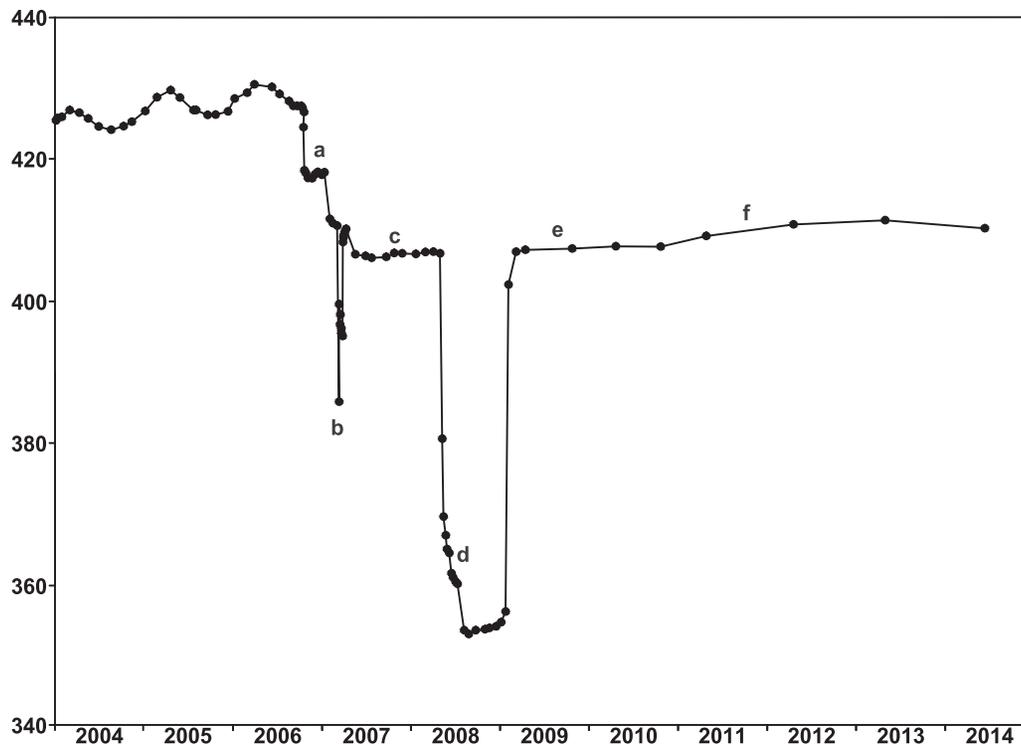
Figure 14. Piezometric surface elevation data from a representative piezometer installed in the confined lower aquifer on the northeast side of the quarry pit. (a) Initial drop in piezometric surface during installation of depressurization wells; (b) brief pumping test on a single depressurization well; (c) well discharge to the quarry pit maintains a constant piezometric surface elevation of approximately 407 ft (the elevation of the well discharge lines); (d) significant lowering of the piezometric surface during pumping of 10 depressurization wells; (e) return to equilibrium conditions following cessation of well pumping; (f) slight rise of the piezometric surface as the lake surface elevation increased and the well discharge lines were inundated.

Between September 2006 and May 2007, 40 depressurization wells were installed on the northeast flank of the quarry to relieve pore-water pressures within the lower aquifer. Based upon the site hydrogeology, lowering of the piezometric surface within the lower aquifer was expected to reduce pore pressures within the overlying unoxidized clay and, in turn, to improve the static FS of the Northeast Block. Immediately upon installation, the depressurization wells flowed at the surface under artesian conditions. As anticipated, the artesian flow resulted in lowering of the piezometric surface of the lower aquifer to roughly the elevation of the well discharge pipes. The piezometric surface at a representative piezometer within the Northeast Block (Figure 14) shows this initial drop. Following installation of the depressurization wells, the displacement rates in slope inclinometer SI-2 decreased to an average of 0.04 in. (1 mm) per year between September 2006 and May 2008 (Figure 12). During May 2008, submersible pumps with float-activated controllers were installed in 10 of the wells. Within 9 days of pump activation, the elevation of the piezometric surface within the lower aquifer (Figure 14) had dropped by 43 ft (13 m). Within 3 months after pump activation, the piezometric surface elevation had dropped an additional 20 ft (6 m).

Following placement and recompaction of the pea gravel fill, drainage of the pit continued, and pit run material was excavated from a shallow borrow area southwest of the pit and placed as compacted fill over the pea gravel using conventional grading methods. As placement of the fill buttress progressed, the slope inclinometer displacement rate slowed to 0.045 in. (0.11 mm) per year between November 2008 and April 2009. The completed fill buttress reached the final elevation of 390 ft (118.9 m) during April 2009. Subsequent monitoring of site slope inclinometers and piezometers from 2009 through 2014 has shown no evidence of an increased rate of movement (Figure 12) even though the piezometric surface of the lower aquifer has risen since pumping of the depressurization wells ceased (Figure 14).
