## LANDSLIDE REPAIR

### CODORNIU NAPA WINERY PROJECT NAPA COUNTY, CALIFORNIA

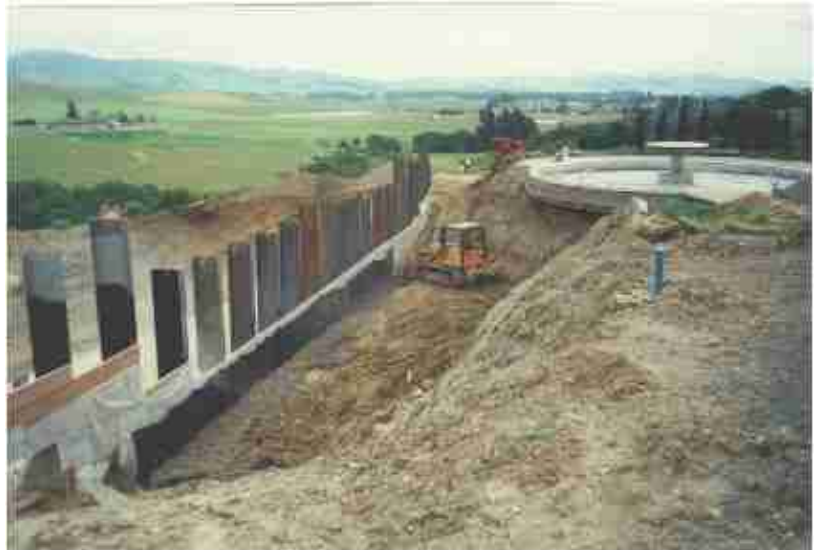
During the winter of 1994-95, a massive landslide destroyed the access road and entry area and threatened to destroy the 26-million dollar Codorniu Napa winery facility located near Napa, California. Cotton, Shires and Associates (CSA) was retained to investigate the failure and provide immediate design of measures to stabilize the hillside. The failure was approached in three phases: 1) protect the winery structure against upslope encroachment of the landslide activity by pinning the upper portion of the landslide, 2) repairing the entry facilities upslope of the pinning to return the winery to limited service, and 3) stabilizing the larger, lower portion of the landslide to restore the main access road and to bring the winery up to full service.

The upper portion of the landslide was pinned in place in the summer and fall of 1995 with a combination buried shear pin retaining wall and a tied-back soldier pile retaining wall. Reinforced concrete shear pins with maximum dimensions of 42 inches in diameter by 50 feet deep and with tiebacks over 125 feet long (unbonded length) and locked off at over 100 kips each. Inclinometer data showed that the shear pin array arrested upward progression of the landsliding. During the winter of 1995-96, the remaining, unpinned 300,000 cubic yards of landslide material situated below the retaining wall moved downslope approximately 80 feet. The main entry fountain area was re-established using curved retaining walls, and re-routing the access road to accommodate traffic. The remaining unstable landslide mass was repaired in the summer and fall of 1996 by constructing an earth fill buttress designed to bring the factor of safety against future failure up to 1.5. Detailed slope stability analyses were performed to balance the stability of landslide debris left in place above and below the buttress fill. This grading involved over 100,000 cubic yards of fill and was completed during the fall of 1996, just prior to the onset of the two, back-to-back wettest months recorded this century. The total construction cost using conventional repair measures (protection pinning and removal and replacement of the landslide) was estimated to exceed \$6 million. The actual cost using our phased approach and detailed analyses was \$2.2 million. CSA provided a total design package on this challenging project, including investigation, design, contract documents, drawings and specifications, construction monitoring and surveying. Structural Engineering was provided by Carl Chan and the General Contractors were Case Pacific/DBM for Phase 1 and Ghilotti Construction for Phases 2 and 3.
